Report 2019-2559

<u>Seismic testing</u>	
Customer	Liquisol bvba
Customer address	Noorderlaan 147 bus 9 2030 ANTWERPEN
Customer contact name	Tom Huysmans
Customer contact telephone	+32 03 2560172
Customer contact e-mail	verf@liquisol.com
Task reference	Testing the effect of a coating on ESC of skylight materials
Jobnr	2559
Contact VKC name	Gaetan Ongenae
Contact VKC tel	+32 56 29 27 18
Contact VKC e-mail	gaetan.ongenae@vkc.be
Report date	20/08/2019

Samples of Skylux were provided with a coating of Liquisol (4EVERblue) and subjected to a bending stress through 7 days at 70°C. After this time period, none of the samples showed any signs of environmental stress cracking.

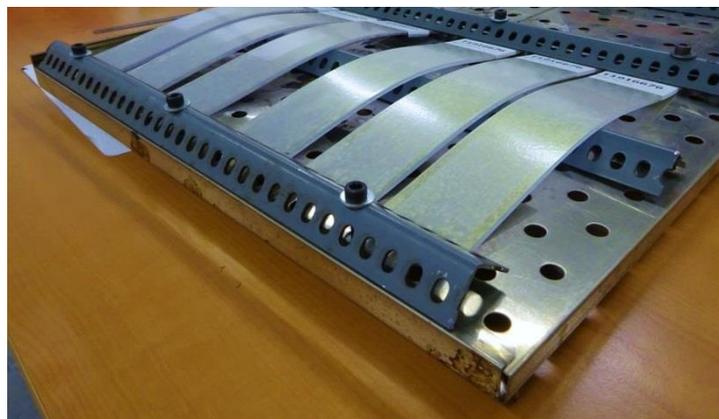
The coated samples are subjected to a continuous bending stress by clamping them on a frame as seen in *figure 1*.

Figure 1: Clamping of the samples PC_3mm en XT_3mm

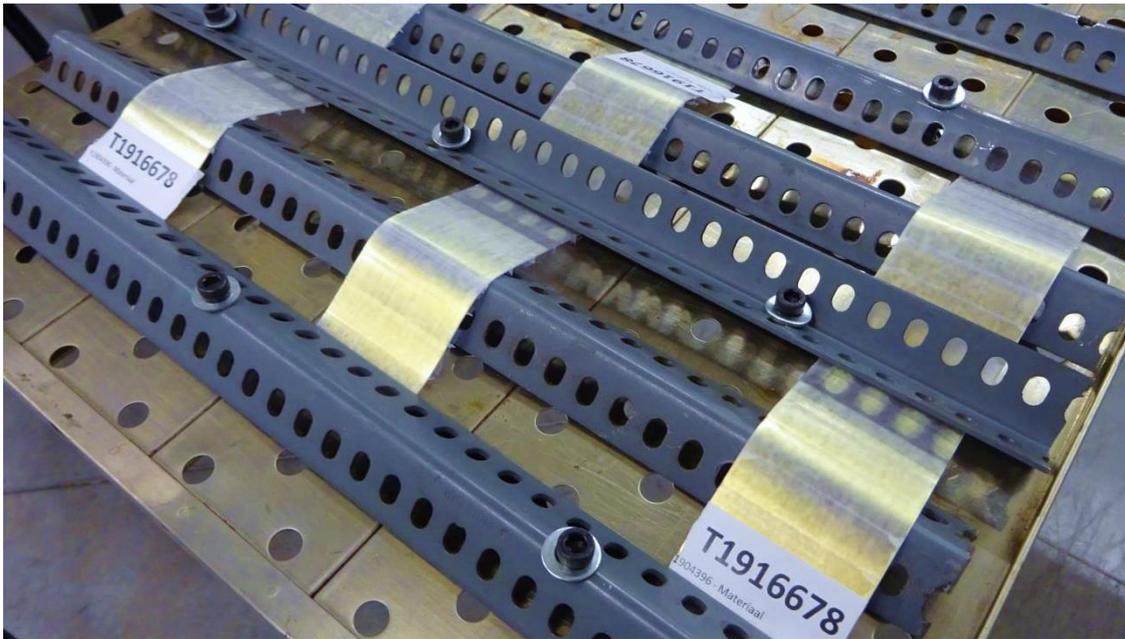
The samples TOP-x5_16mm consist of two thinner sheets interconnected by ridges (total thickness of sample = 16 mm). These ridges make applying a bending stress to the samples difficult. They tend to collapse rather than bend. Because of this, the coated top layer is separated (using a belt saw). The resulting sample is only 0,7 mm in thickness. Compared to the other samples (both of which are 3 mm thick) this thin sheet is much more flexible. Clamping as illustrated in *figure 1* will lead to insufficient stress in the samples. The method of clamping these samples is shown in *figure 2*.

Figure 2: Clamping of the samples TOP-x5_16mm

Be aware however that the samples for TOP-x5_16mm were thinner and thus clamped differently on the frame. These samples experienced a different stress compared to the samples for XT_3mm and PC_3mm (they cannot be compared directly).

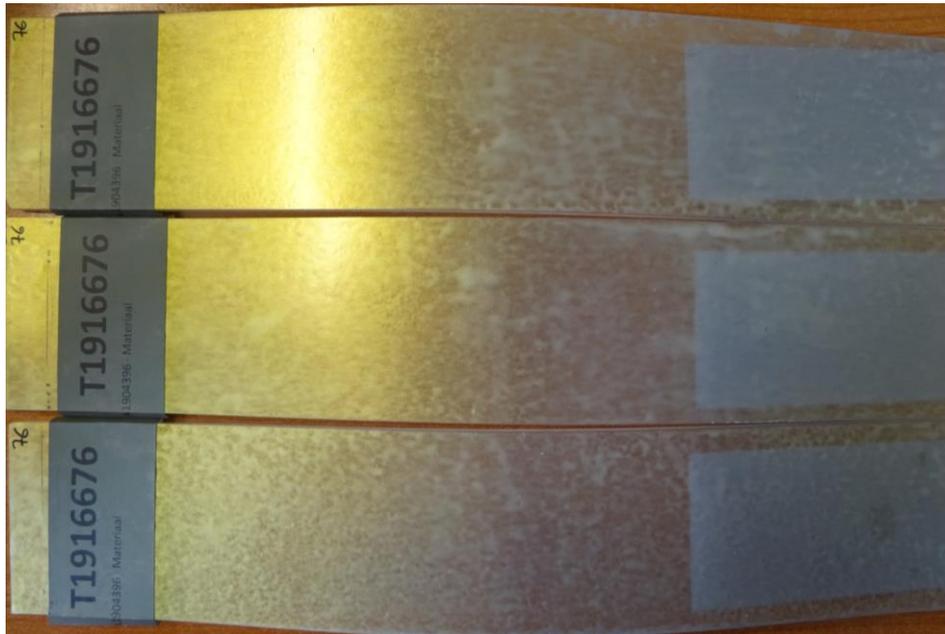
Figure 3: Samples XT_3mm after ageing

None of the samples show signs of environmental stress cracking after ageing for 7 days in an oven at 70°C.

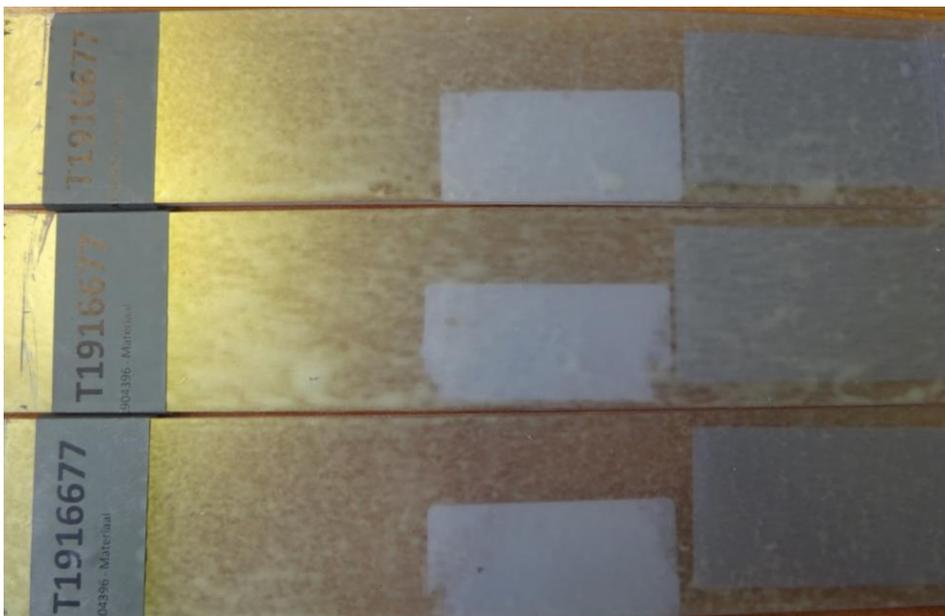
Figure 4: Samples PC_3mm after ageing

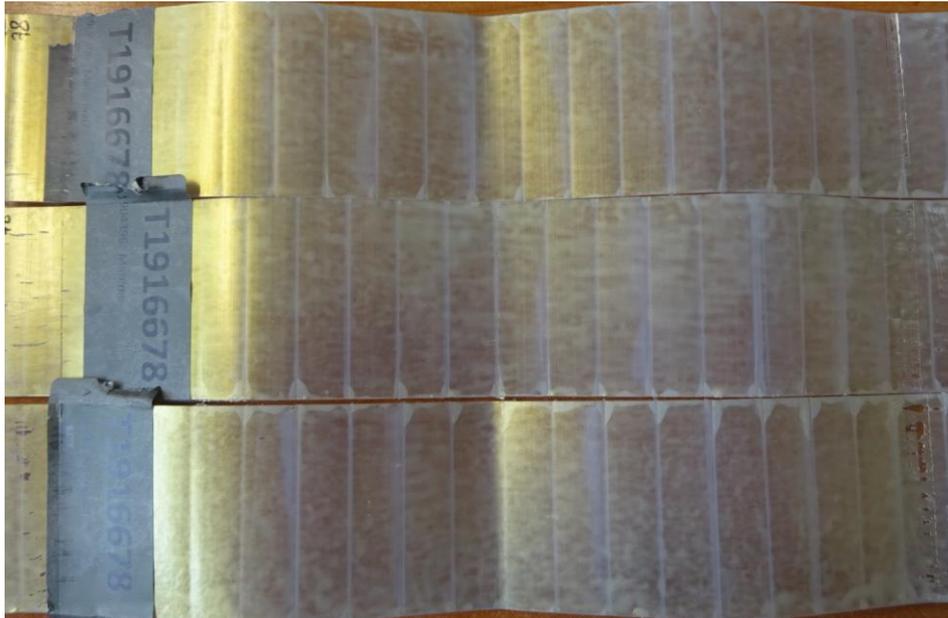
Figure 5: Samples TOP-x5_16mm after ageing
